# Public Employees for Environmental Responsibility

October 8, 2019

Public Employees for Environmental Responsibility (PEER) is writing to make you aware of a potential violation of the Wetlands Protection Act, MGL Ch. 131 Section 40, at Chilson Park, Beaver Street, in Franklin, Massachusetts (see Figure 1 for National Wetlands Inventory screenshot of the area). The potential violation is to the east of the existing turf field adjacent to the wetland labeled “PABH.” It appears that this area is within a DEP Approved Zone II Water Resource District.<sup>1</sup>

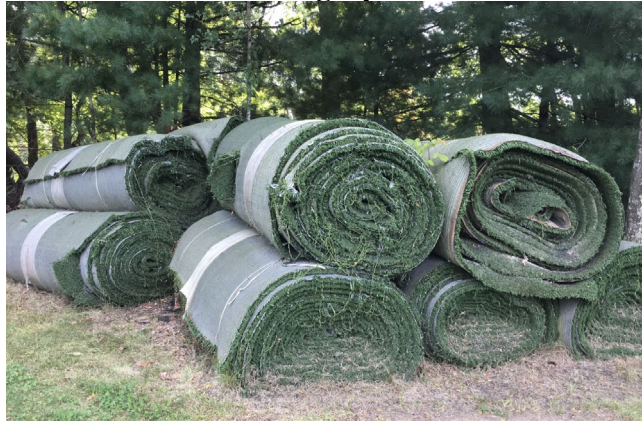
**Photograph 1**

Specifically, there were approximately 11 rolls of discarded artificial turf (see Photograph 1),<sup>2</sup> and four bags of rubber crumb infill (see Photograph 2),<sup>3</sup> within 34’ to 45’ of a wetland and stream system. These materials were dumped in this area in or around 2017, and the rubber crumb and grass shreds are making their way into the wetland (see Photograph 3).

<sup>2</sup> Each roll is roughly 7’ 6’ long, and 3’4” in diameter.

In fairness to the Town of Franklin, no one outside of the turf manufacturers knew, until last week, that artificial turf contained PFAS. However, the chemicals in the crumb rubber were well known, and have been for years. PEER respectfully requests that Massachusetts Department of Environmental Protection investigate this matter. Pursuant to 310 CMR Section 10.08, when the Department determines that an activity is in violation of M.G.L. c. 131, § 40 and 310 CMR 10.00, the Department may issue an enforcement order for failing to obtain a valid Order of Conditions prior to conducting an Activity Subject to Regulation. Moreover, PEER requests that you look into the failure to comply with Condition Number 55 (water quality monitoring). Finally, PEER urges you to test the existing turf field for PFAS, and determine whether PFAS is leaching into Franklin's wetlands.

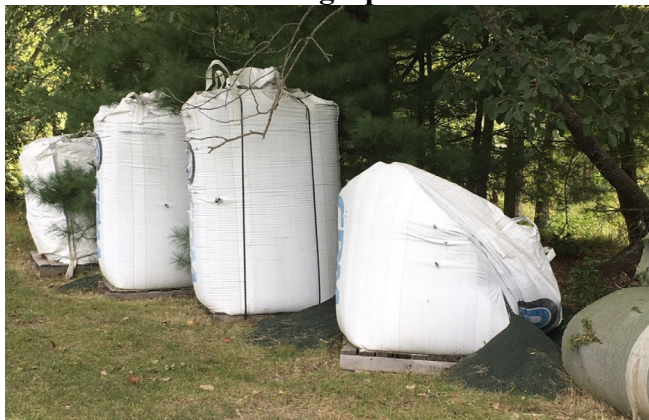
**Photograph 2**

<sup>3</sup> The crumb rubber bags are approximately 5’ tall and 3’4” wide.

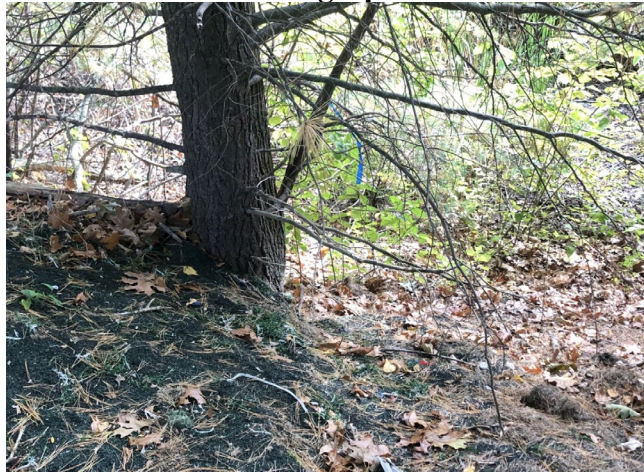
**Photograph 4**

In one location, a large quantity of crumb rubber was spilling down a hill into the wetlands, beyond the blue wetland flag (see Photograph 4).

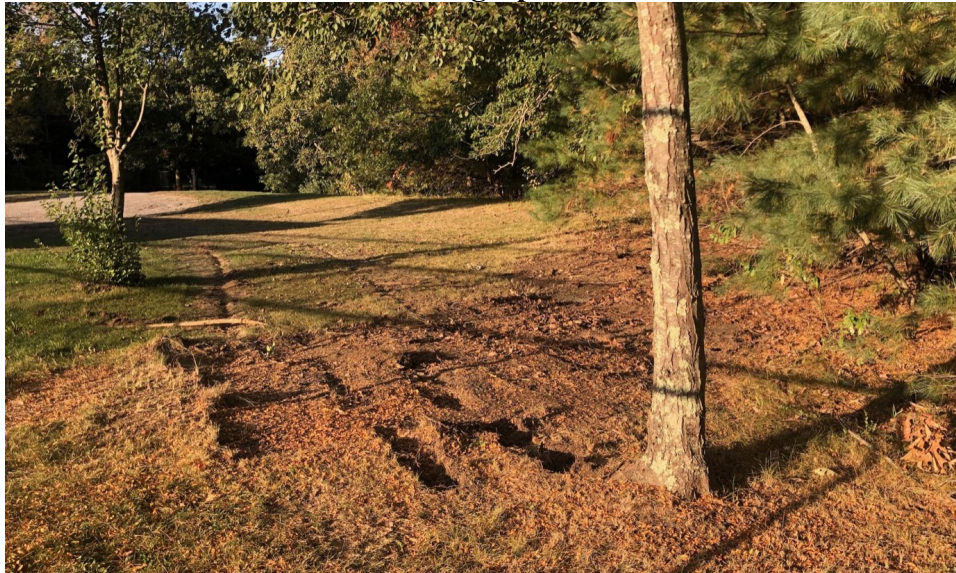
**Photograph 5**

On September 30, 2019, after a reporter questioned Town employees about the rolls of turf and bags of crumb rubber in the buffer zone, the turf and the bags were relocated, presumably by Town employees. Ruts from the vehicles and depressions in the soil show where the rolls used to be are visible (see Photograph 5). Moreover, it appears that some type of shovel or heavy equipment removed the loose piles of crumb rubber (see Photograph 6).

PEER believes the Town moved the piles when they learned of this forthcoming complaint from the reporter. It is clear that the Town of Franklin was trying to correct the potential violation, but in doing so they may have inadvertently created additional violations of the Wetlands Protection Act. Moreover, removal of the turf and the crumb rubber may not obviate the need for additional remediation. If crumb rubber, PFOS, and/or other contaminants leaked into the wetlands and stream during the two years the piles and bags were there, Franklin's drinking water supply may be impacted.
